## **MAIN STRUCTURAL SUPPORTS**

### **I. GENERAL**

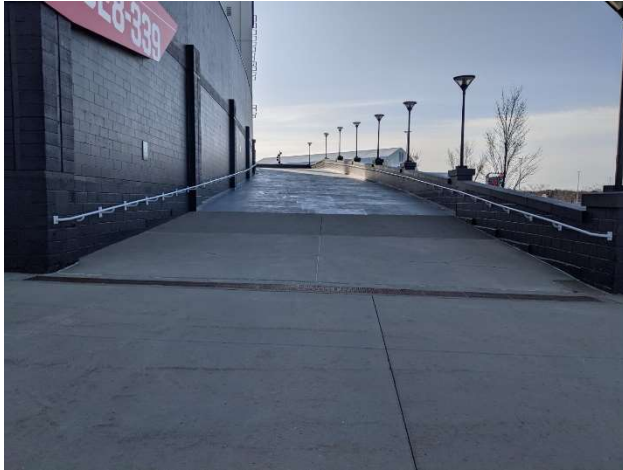
**Photo 5-01**  
General Photo of Ramp to 300 Level.

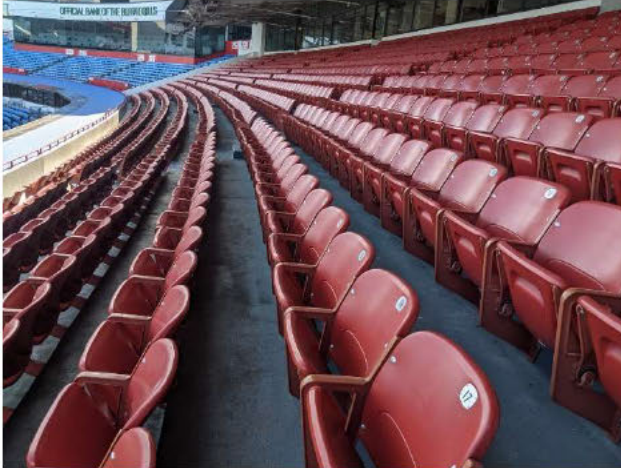
**Photo 6-01**  
General Photo of 200 Sideline Club Seating Area.

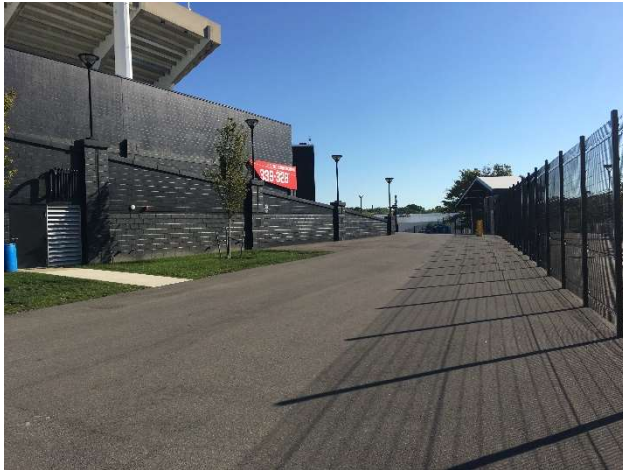
**Photo 7-01**

General Condition of Asphalt Pavement throughout the 200 Level Concourse.

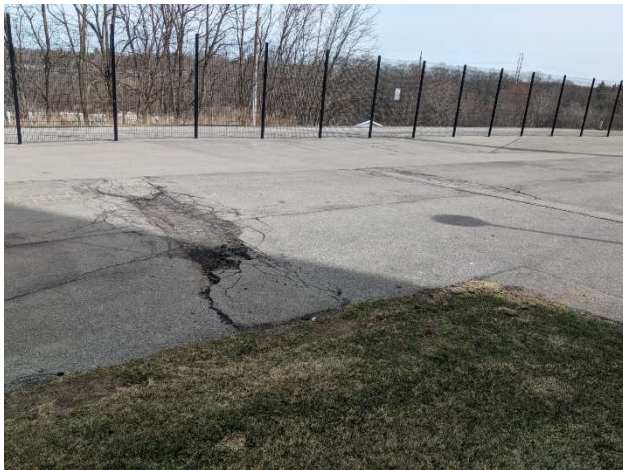
**Photo 7-02**

Asphalt Concourse Pavement at East End of the Stadium; between Old Administration Building and Security Fence.

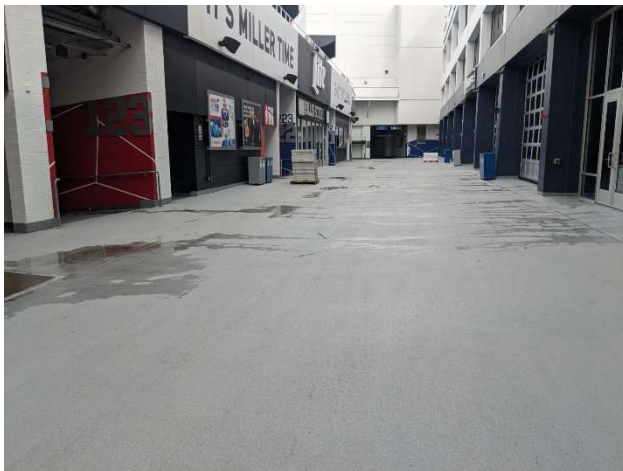
**Photo 9-02**

General Photo of Structural Slab and Traffic Coating in East End of Stadium.

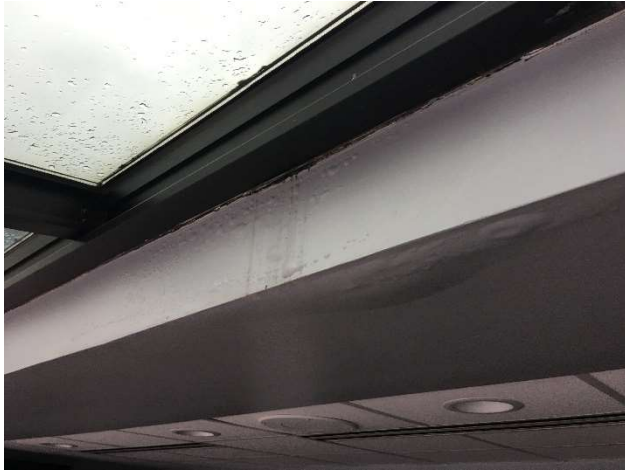
**Photo 12-01**  
Typical Dugout suite with water infiltration

**Recommendations:** The dugout suite window/skylight assembly has a 25 year life expectancy. Currently the windows have been installed for 22 years. While the life expectancy says that the windows should be replaced within the next 5-10 years the ongoing sealant replacement and maintenance that is takes place on the windows can push back their need for replacement. If the sealant repairs fail to mitigate water infiltration that develops or if frame and window damage becomes excessive, their replacement will become a priority.

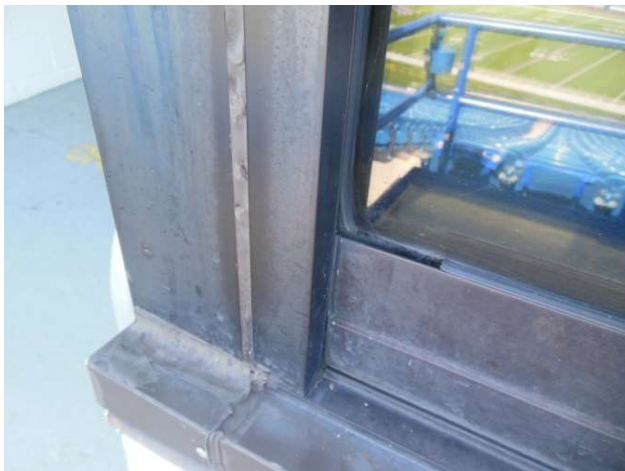
While the interior finishes have been replaced and updated, the skylight/window system is still original from when the dugout suites were installed and could be a cause for future concern. In the summer of 2015, the glazing sealant was replaced. Areas of concern are addressed by the Buffalo Bills as needed. There are several areas where the window system shows signs of failure such as the perimeter sealant at several windows which has released from the corners and can leaves the frame and glazing units vulnerable to wind driven rain and snow (Photo 12-02).

**Photo 12-02**  
Dugout suite aluminum window with failed window gasket

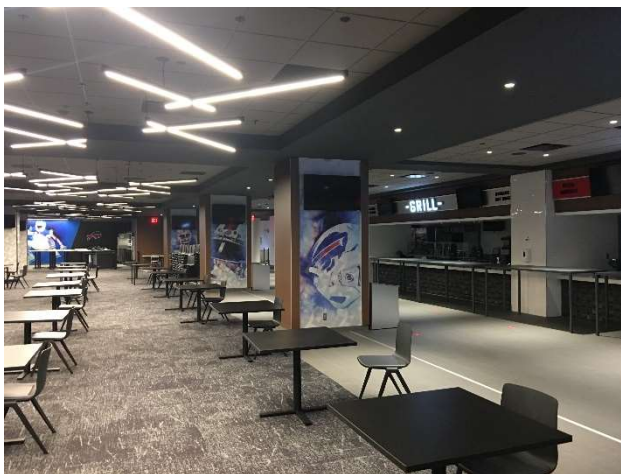
**Photo 12-05**

The Pepsi East and West Clubs, along with the Toyota and Dunn Tire Clubs were constructed during the 1998/1999 lease project. The clubs were fully renovated during 2018 and are in like-new condition (Photo 12-05).

Renovated Pepsi Club Suite

**Recommendations:** There are no recommendations at this time.

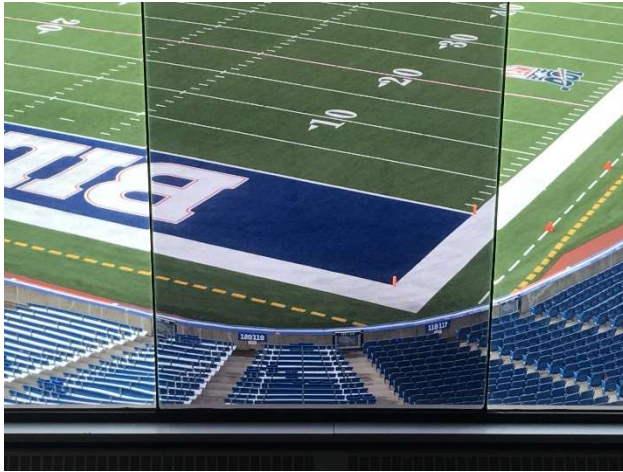
The panoramic windows facing the field are an aluminum frame window system with butt glazing that were installed on the second floor during the 1998/1999 lease project. The first floor windows, also aluminum frame windows with butt glazing, were installed in 1994 during the construction of the first floor clubs. The windows are in good condition however sealant at the sill flashing is beginning to fail and are a potential place for water infiltration (Photo 12-08). Also, there are 4 units that are either cracked (Photo 12-09) or replacement units that are different color than the original (Photo 12-08).

**Photo 12-10**  
Discolored glazing unit at Club Suites

**Recommendations:** As noted in the roofing section the skylights should be replaced when the roof is replaced. The first floor aluminum storefront window system is 27 years old and the second floor is 23 years old. The life expectancy for an aluminum storefront window system is 40 years. Replacement of the sealant at the first and second floors of both club seats at the sills is recommended.

Finding a replacement glazing unit that will match the remaining glazing is difficult, while the units which are not a matching color are an aesthetic change the cracked unit that faces the field is an obstruction to guests view and should be replaced within the next 5 years.

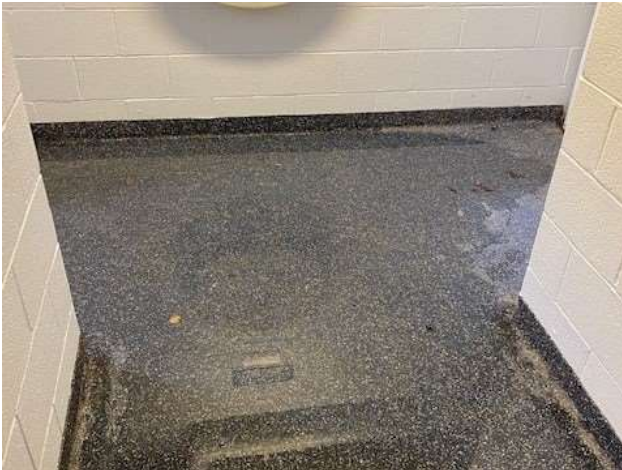
**Photo 13-05**  
Water infiltration in Berm Bathroom 134

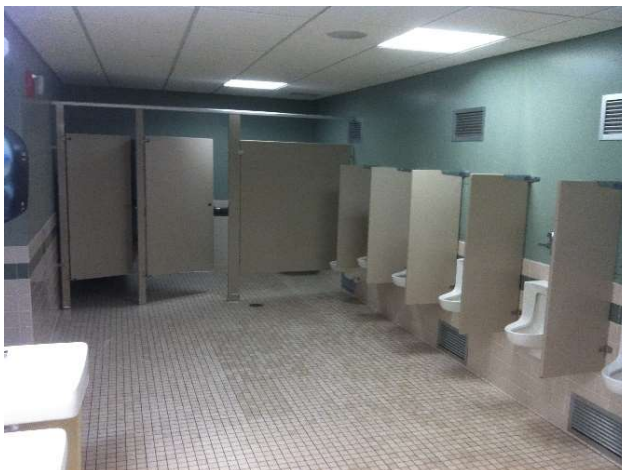
**Photo 13-06**  
Pepsi Club Suite Restroom

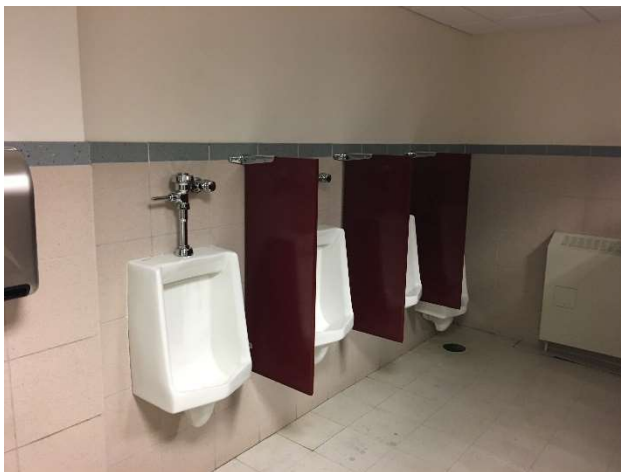
**Photo 13-08**  
Business Class Club Men's Restroom

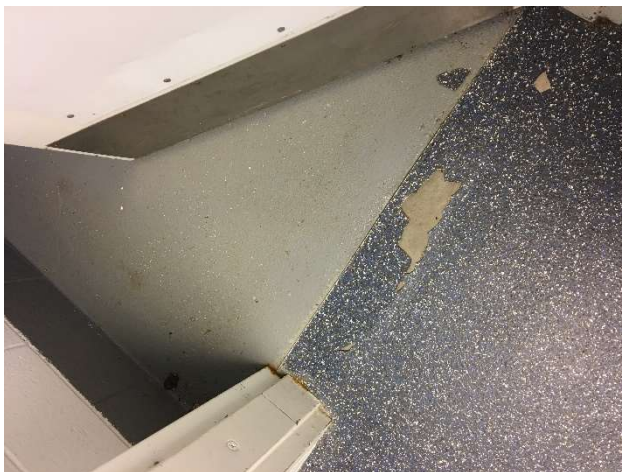
**Photo 13-12**  
Failed Epoxy Floor at Restroom 308

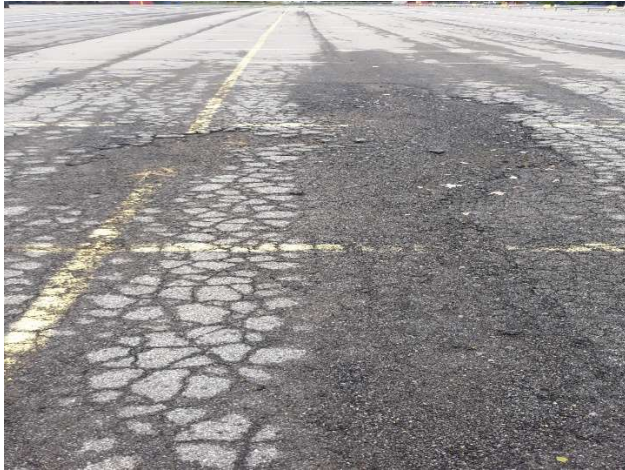
**Photo 18-01**  
Asphalt deterioration in Lot 1.

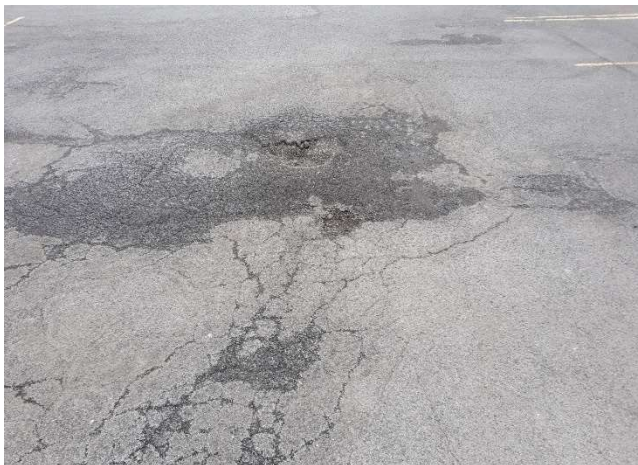
**Photo 18-02**  
Western portion of Lot 2.

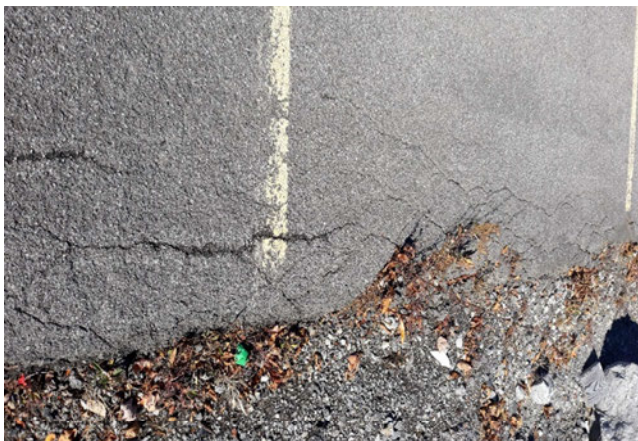
**Photo 18-03**  
Lot 7 North pavement failure at unrestrained east edge.

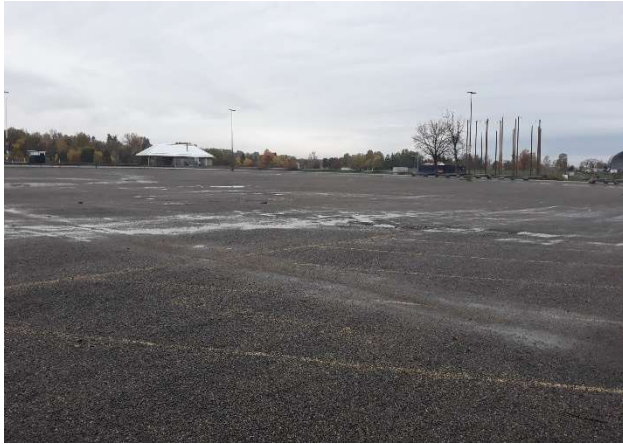
**Photo 18-04**

Camper Lot (reconstructed in 2015), note minor ponding.

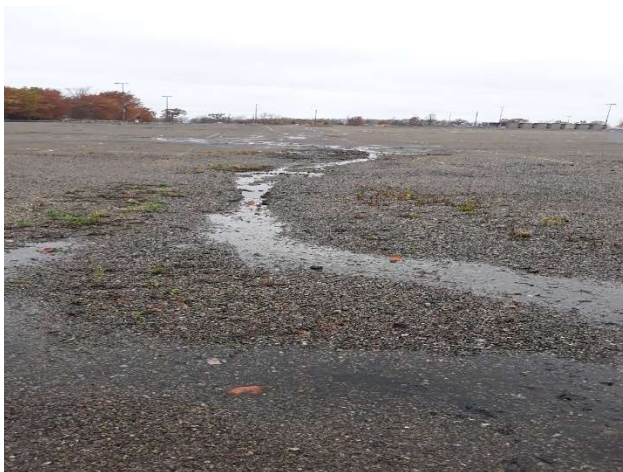
**Photo 18-06**

Deterioration of shot and chip in Lot 3 with percolation of ground water.

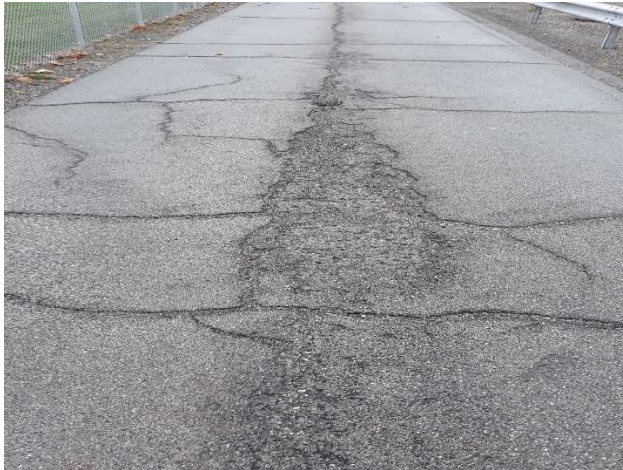
**Photo 18-10**

Longitudinal, transverse and map cracking with raveled pavement at pedestrian walkway on west side of Abbott Rd.

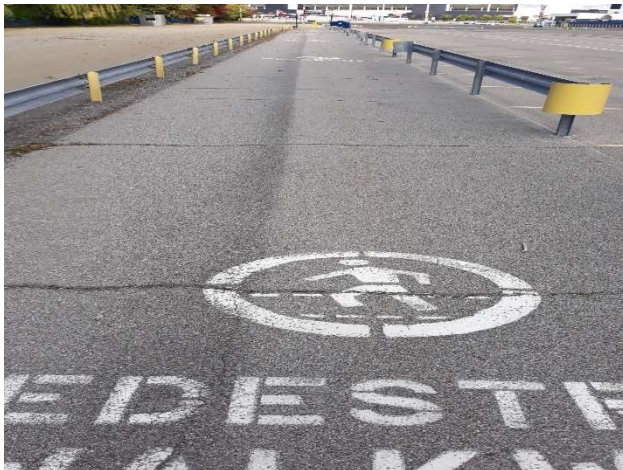
**Photo 18-11**

Pedestrian walkway along Fieldhouse Dr.

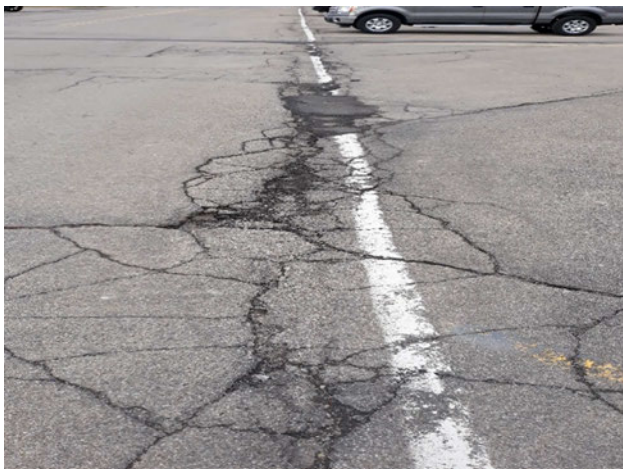
**Photo 18-12**

Asphalt map cracking and potholes at Drive C.

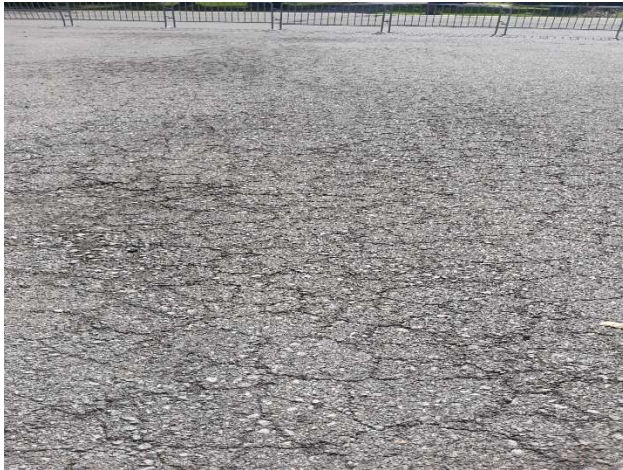
**Photo 18-13**

Asphalt map cracking at Fieldhouse Drive entrance from Route 20A.

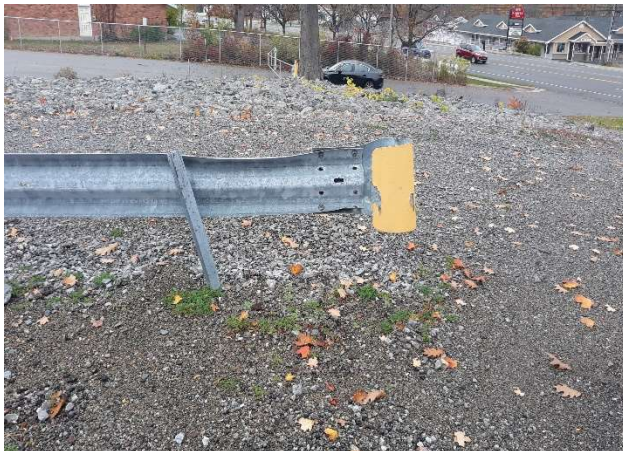
**Photo 18-14**

Typical guide railing damage.

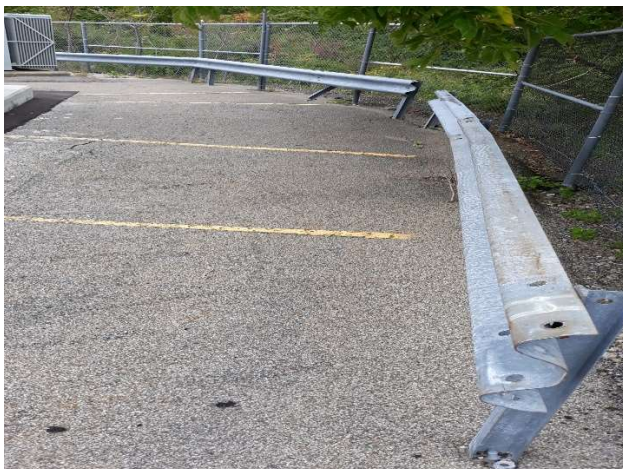
**Photo 18-15**

Missing end sections (typ.).

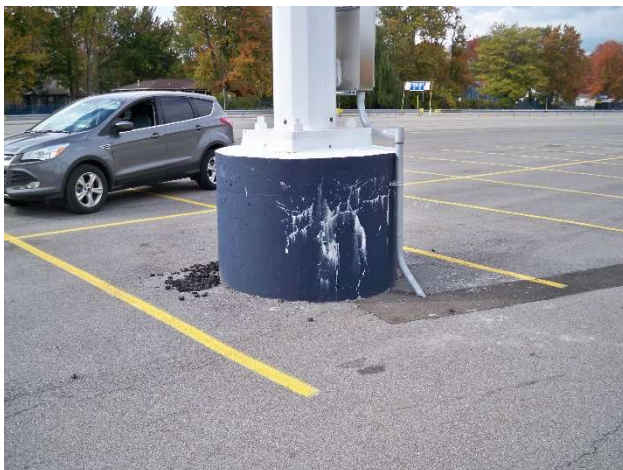
**Photo 18-18**

Light pole base with cracking and efflorescence

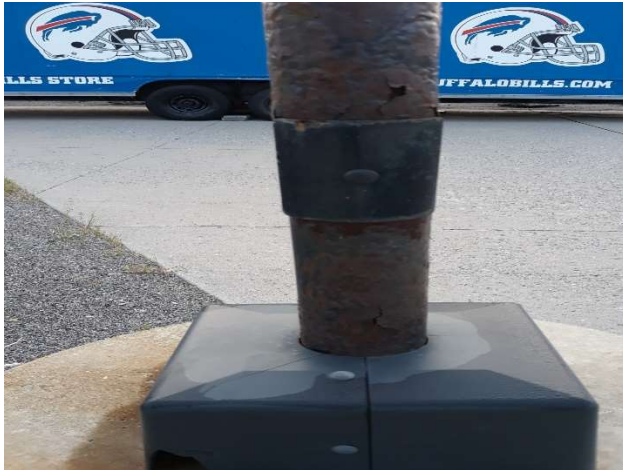
**Photo 18-19**

Corrosion/rusting on light poles with single and twin luminaires. Typical on poles in Lot 2 ADA, west service gate, Gates 2, 3,4 and 5, Bills Store, Founders Plaza and the Commissary Building Lot.

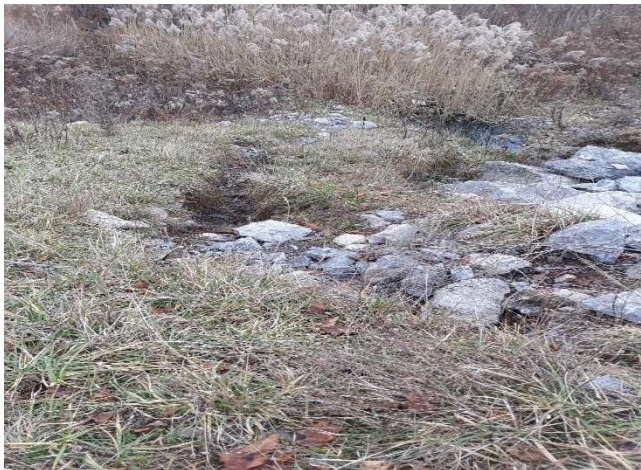
**Photo 18-20**

Erosion beyond limits of stone protection at stilling basin

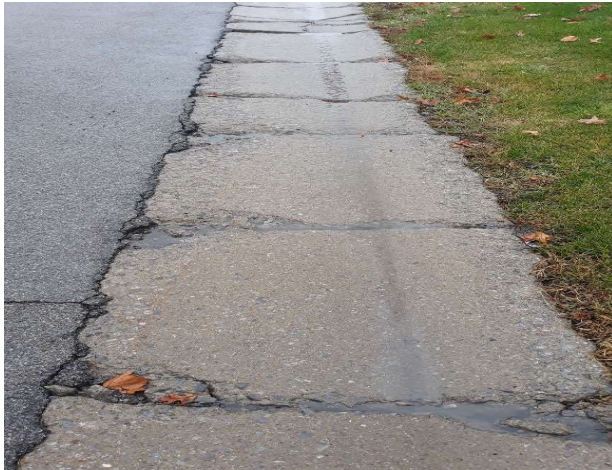
**Photo 18-22**

Broken concrete gutter curb along the west edge of Access Rd. 'C'

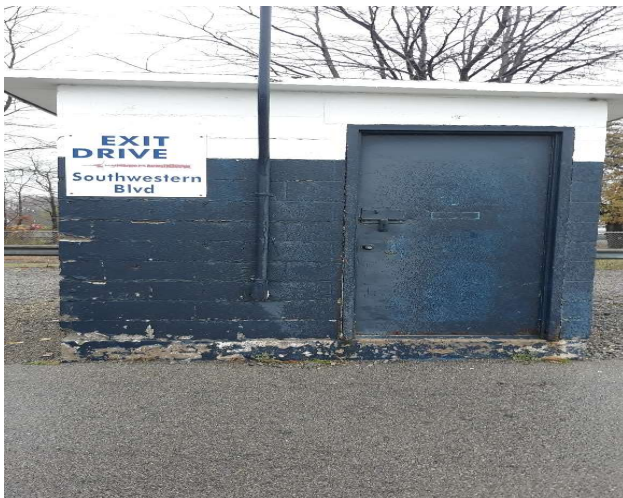
**Photo 18-23**

Lot 4 parking attendant booth.

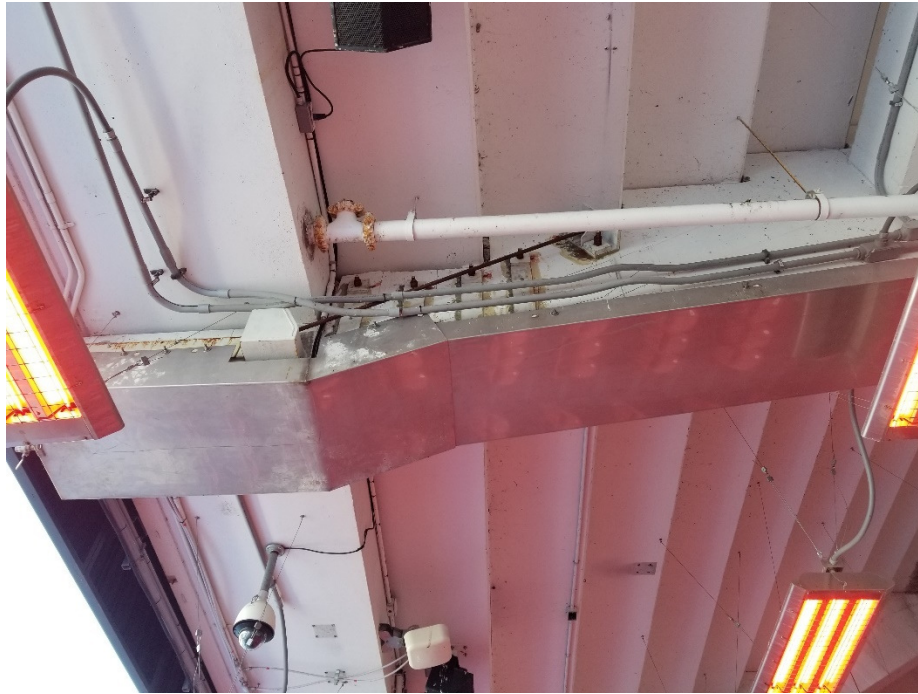
Image E22 Typical IR Heater Broken Conduit and Supports

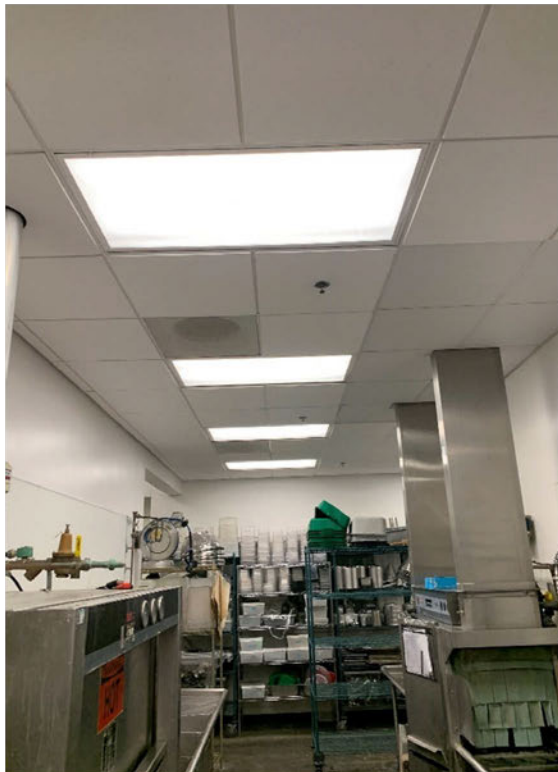
Image E44 Typical Recessed 2'x4' Lighting

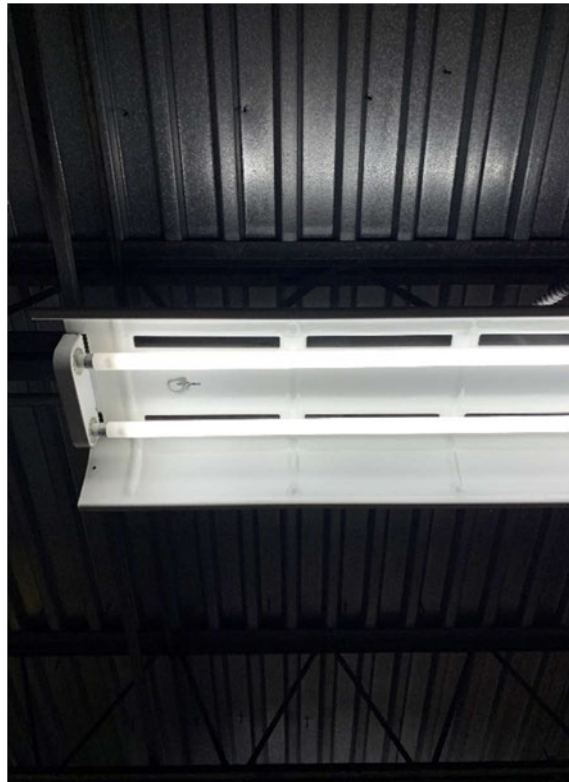
The existing lighting consists of chain suspended 2'x4' (2) lamp T8 Industrial fluorescent fixtures and was installed in the 1999 project (Image E52). The existing lighting controls for the space consists of a lighting switch at the entry door.

Image E52 Typical Suspended 2'x4' Fluorescent Fixture
