## **MAIN STRUCTURAL SUPPORTS**

### **I. GENERAL**

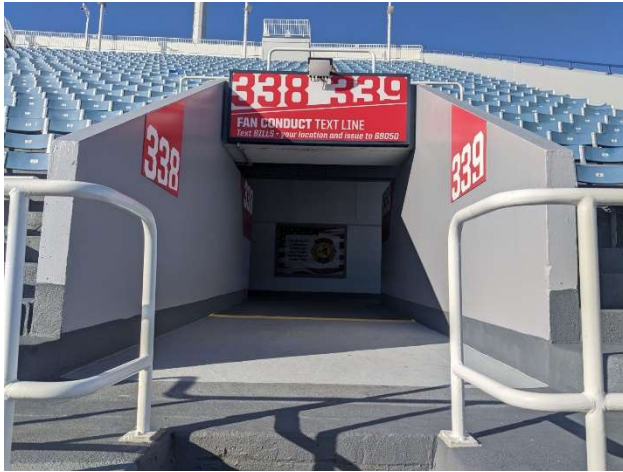
**Photo 4-07**  
General Photo of Vomitory Construction.

Eleven vomitories provide access from the concourse to the seating areas on each side of the stadium (Photo 4-07).

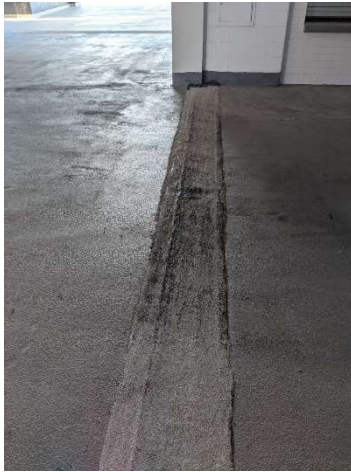
**Photo 5-04**

General photo of Expansion Joint within Interior Concourse.

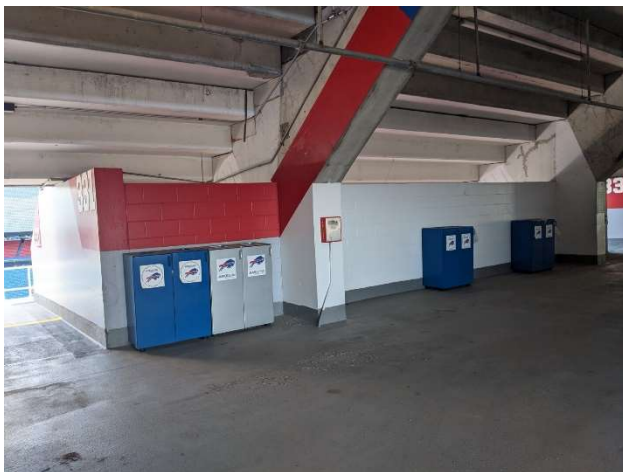
**Photo 5-05**

General photo of Masonry Construction along Field Side of Concourse.

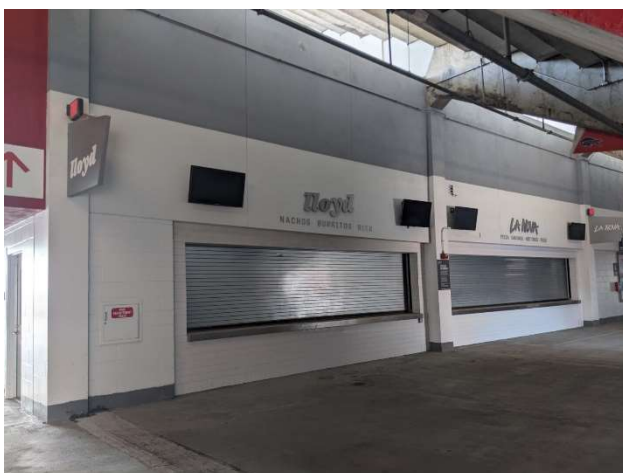
**Photo 5-06**

General Photo of Masonry Construction along Exterior Side of Concourse.

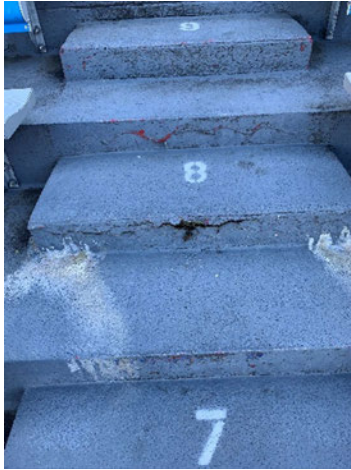
**Photo 6-07**  
Cast-in-Place Stair with Spalling and  
Efflorescence.

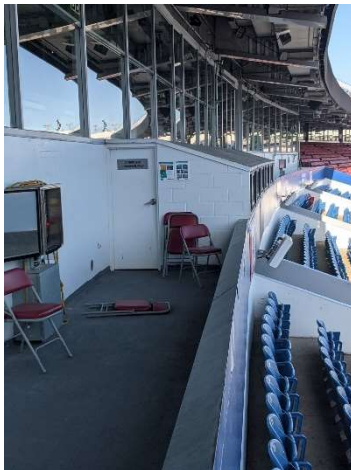
A camera deck extends across the south side of the club level on the field side of the Broadcast Booth and Super Suites (Photo 6-08). [REDACTED]

**Photo 6-08**  
General Photo of Precast Camera Deck.

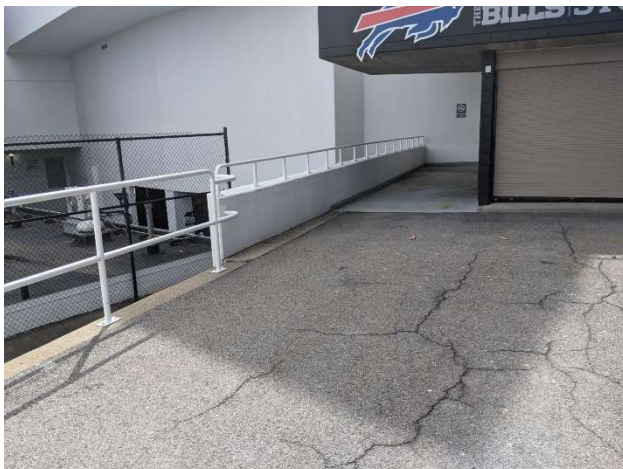
**Photo 7-03**

At each of the Stadium's four corners are concrete fascia panels with metal railings that span along the pedestrian walkways adjacent to the End Stair Towers (Photo 7-03). These panels serve as railings protecting against falls to 100 Level concourse located below.

General Photo of Concrete Fascia with Metal Railing.

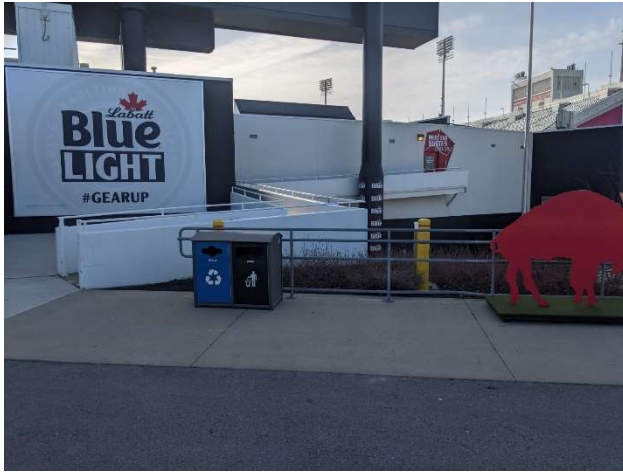
**Photo 7-04**

Two structural ramps provide access to doorways located near the middle of the West End Suites; beneath the main scoreboard (Photo 7-04). [REDACTED]

General Photo of ramps to West End Suites

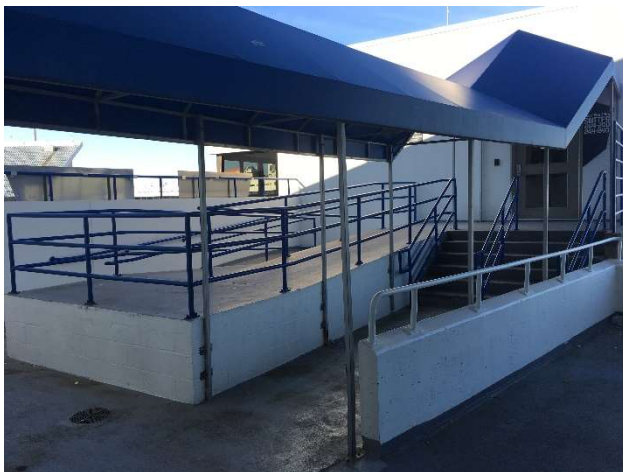
**Photo 7-06**

Two accessible switch back ramps are located at the north and south ends of the west end suites (Photo 7-06). [REDACTED]

General Photo of Switch Back Ramps to  
West End Suites.

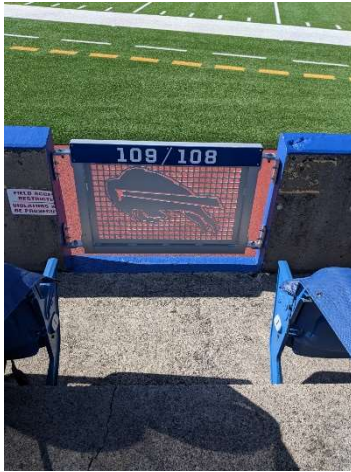
**Photo 8-07**  
Gate Providing Access to Playing Field from  
100 Level Seating Area.

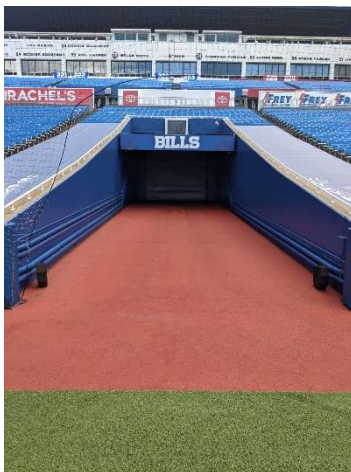
**Photo 8-09**  
General Photo of Tunnel Entrance Retaining  
Walls.

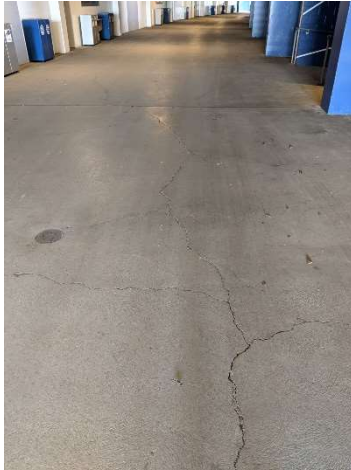
**Photo 9-01**

General Photo of Concrete Slab-On-Grade in 100 Level Concourse, Typical Cracks in Slab

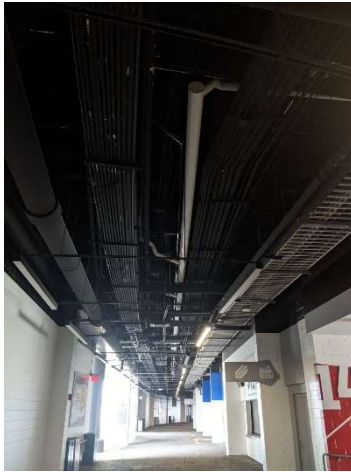
**Photo 9-07**

Various Improvements and Utilities  
Obstructing Inspection of Concrete Ceiling  
Plank.

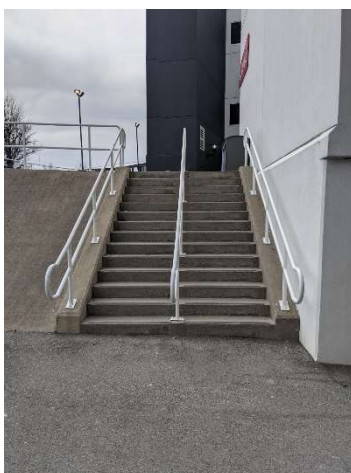
**Photo 10-03**  
General Photo of Stairs south of Old Administration Building.

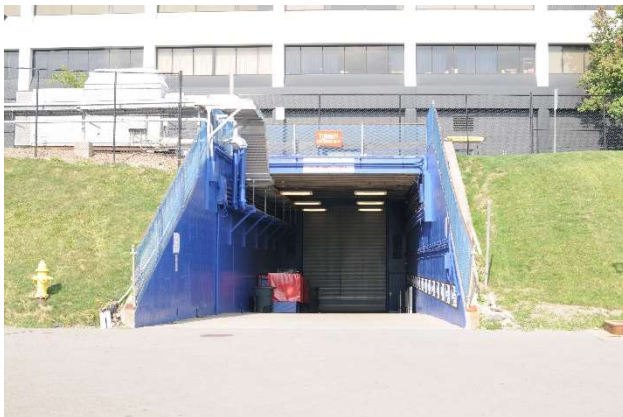
**Photo 10-06**  
General photo of Exterior Tunnel Retaining Walls

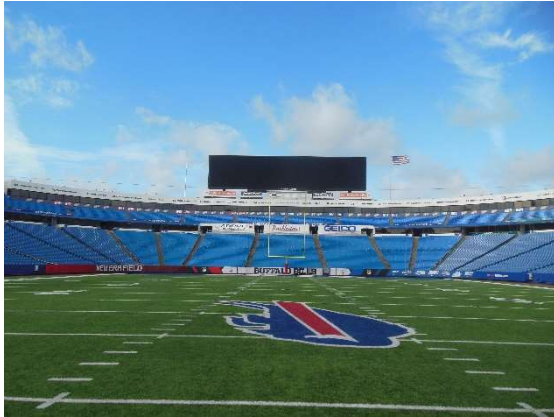
The original scoreboard structure is over 42 years old. This structure has been modified and expanded three times. The first modification in 1994 was the installation of the Sony Jumbotron Videoboard. It measured 31.5 feet by 41.5 feet and at the time was one of the largest in the United States. Adjacent to the JumboTron were six Daktronics Scoreboards. Then in 2007 modifications were made to accommodate the new high definition diamond vision provided by Mitsubishi. After these modifications, the scoreboard was approximately 33.5 feet by 82.5 feet and provides a high definition picture for instant replays and live action. Lastly, the scoreboard length was almost doubled in 2014. In its current configuration the scoreboard now measures approximately 33.6 feet by 163.78 feet (Photo 10-07).

**Photo 10-07**  
General photo of Main Scoreboard

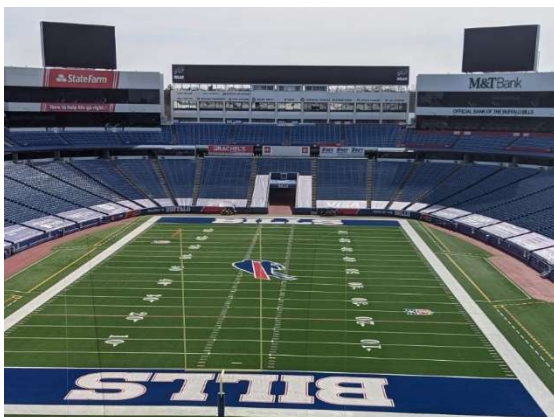
**Photo 10-09**  
General Photo of Trivision and Goal line Club  
Video Displays

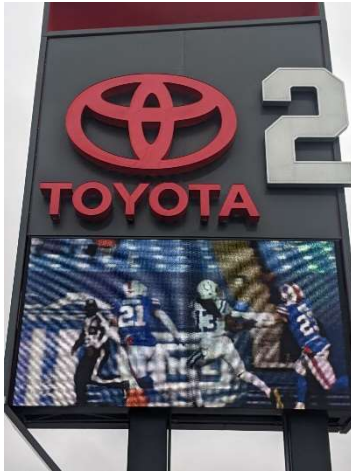
There are 6 Gate Signs with video screens on both faces, adjacent to Gate Canopies 2 through 7. The screens are used to display information, advertisements, and videos during events on game days. The screens also display video 24 hours a day, seven days a week. The video screen modules are beyond their expected lifespan. The screens on the west of Gate 3, north of Gate 4, and north of Gate 5 exhibit minor deterioration with isolated failed pixels. Screens on the west of Gate 2, south of Gate 4, south of Gate 5 west of Gate 6 and west of Gate 7 all exhibit moderate deterioration with sporadic failed pixels and discolored display (Photo 10-16). The east screen of Gate 6 has a failed line of approximately 24 pixels in the center of the screen. The west screen of Gate 6 has a failed module in the bottom right of the screen (Photo 10-17).

**Photo 10-16**  
Typical Gate Video Screen with deteriorated pixels.

**Recommendations:** The video screens are beyond their expected lifespan and should be considered to be replaced due to the level of deterioration and the extensive use of the screens.

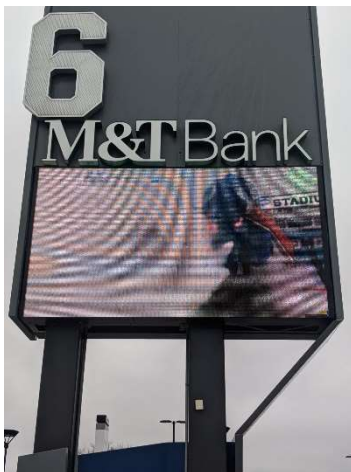
**Photo 10-17**  
Gate 6 West Video Screen with Failed Module in Bottom Right Corner.

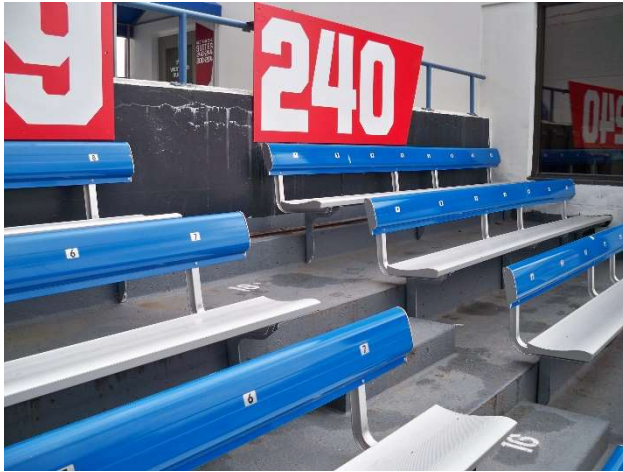
**Photo 11-04**

General Photo Showing Top Row; Access is Difficult on Backside to Rivet Seats.

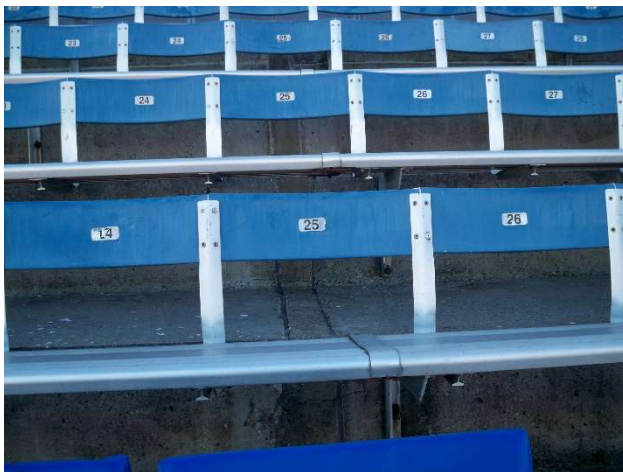
**Photo 11-05**

There are 21,934 upper deck bench seats located along the sidelines of the stadium. These seats are the original bench seats that were installed in 1973 and constructed of an extruded aluminum bench with individual dished contoured backs (Photo 11-05). The backrest of the seats is connected by rivets (two on each side of seat) to an aluminum bracket which is then bolted to the underside of the bench seat. The bench seat is then anchored and bolted to the vertical face of the concrete step.

General Photo of Riveted Attachment of Seats in Upper Deck (300 Level).

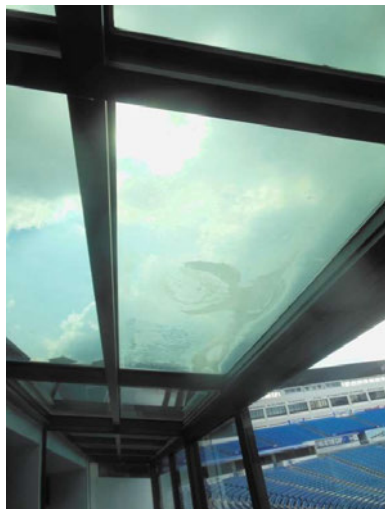
Some of the horizontal (skylight) windows have abnormal staining (Photo 12-03) within the glazing system which would indicate that the seals have been compromised and moisture has penetrated into the air space between the glazing panes. While it was not raining during this inspection, water was observed at some of the dugout suite sills (Photo 12-04) which would indicate that some components of the window unit have failed and water is entering the suite through the window. In addition to sealant replacement at the windows the first row of the 200 level seats have had traffic coating installed to help with water infiltration into the suites below. Additionally, the concrete ring wall in front of the first row of the 200 level seats and above the dugout suites have been repaired.

**Photo 12-03**  
Dugout suite with stained skylight window

**Recommendations:** The dugout suite window/skylight assembly has a 25 year life expectancy. Currently the windows have been installed for 22 years. While the life expectancy says that the windows should be replaced within the next 5-10 years the ongoing sealant replacement and maintenance that is takes place on the windows can push back their need for replacement. If the sealant repairs fail to mitigate water infiltration that develops or if frame and window damage becomes excessive, their replacement will become a priority.

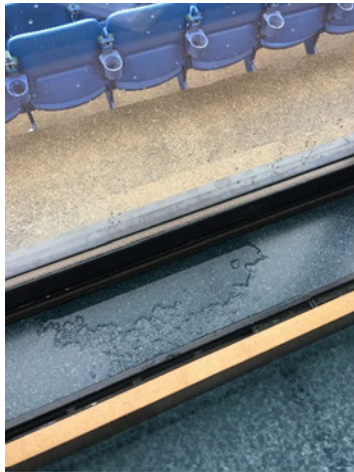
**Photo 12-04**

Dugout suite with water infiltration at window sill

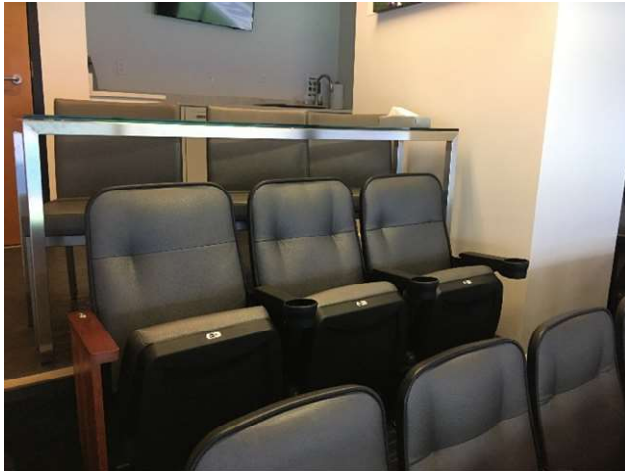
The sideline club suites, which are original from the 1972 construction, are directly off of the club rooms and are located directly under the 300 level deck are in very good condition with their finishes being well maintained over the years. Tiered seating exists in almost all the units (Photo 12-06). The sliding windows are 48 years old, these windows are in better condition than the dugout suite windows due to the fact that they are protected by the 300 level deck above. Several suites have had their interior finishes updated over the years (Photo 12-07)

**Photo 12-07**  
Renovated sideline suite

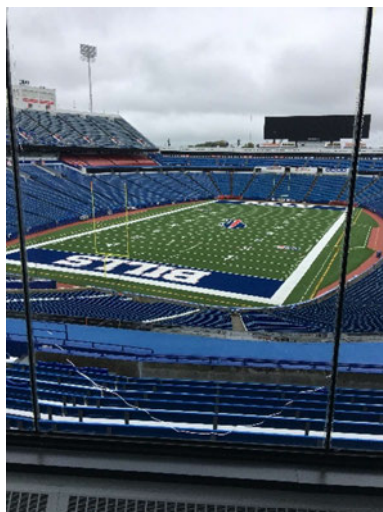
The panoramic windows facing the field are an aluminum frame window system with butt glazing that were installed on the second floor during the 1998/1999 lease project. The first floor windows, also aluminum frame windows with butt glazing, were installed in 1994 during the construction of the first floor clubs. The windows are in good condition however sealant at the sill flashing is beginning to fail and are a potential place for water infiltration (Photo 12-08). Also, there are 4 units that are either cracked (Photo 12-09) or replacement units that are different color than the original (Photo 12-08).

**Photo 12-09**  
Cracked glazing unit at Club Suites

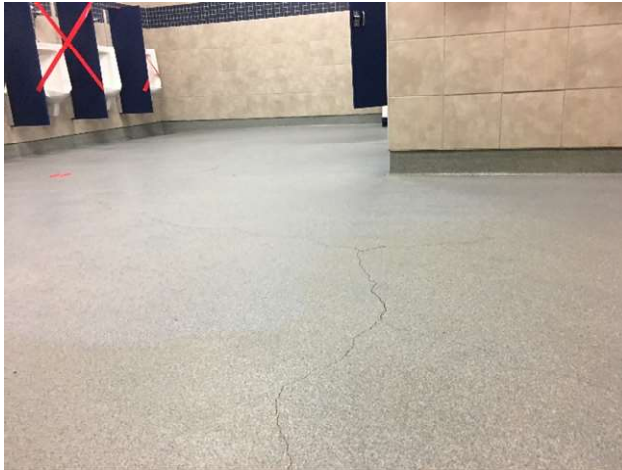
**Photo 13-04**  
Men's Restroom 138 floor

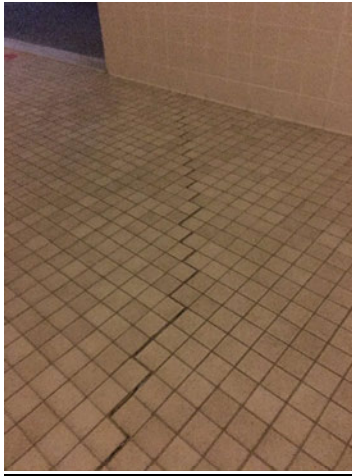
**Photo 13-07**  
Cracked Tile Floor in Women's Restroom 213

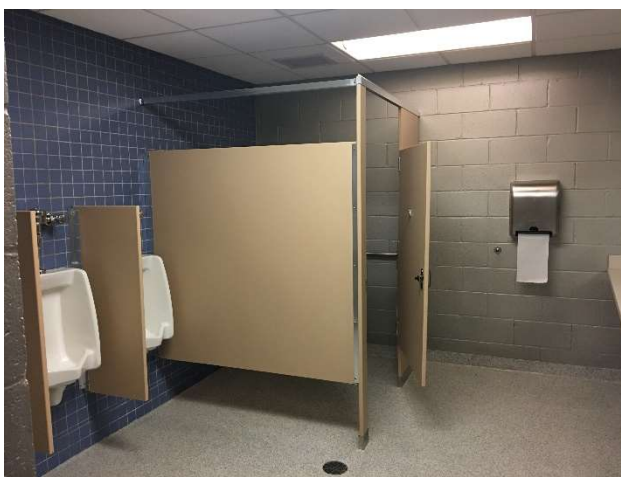
The West End Suite has 6 public bathrooms for use by the suite holders. There are 3 Men's rooms and 3 Women's rooms. The restrooms are in good condition with epoxy flooring, solid surface countertops with integral sink bowls. The restrooms also have tan HDPE toilet partitions with 2x2 wall tile on the walls directly behind the toilets while the remaining 3 walls are freshly painted CMU (Photo 13-09).

**Photo 13-09**  
West End Suite Men's Restroom

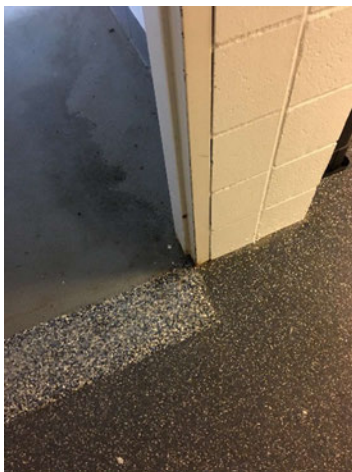
**Photo 13-13**  
Repaired Epoxy Floor at Restroom 307

**Recommendations:** There is no work that is required at this time with the exception of epoxy flooring repairs. It is recommended the flooring in 308 exit door be repaired as soon as possible to prevent further flooring deterioration. Similar delamination was observed in the adjacent restroom 307 on the previous condition survey and repaired (Photo 13-13). The same repair should take place at this location.

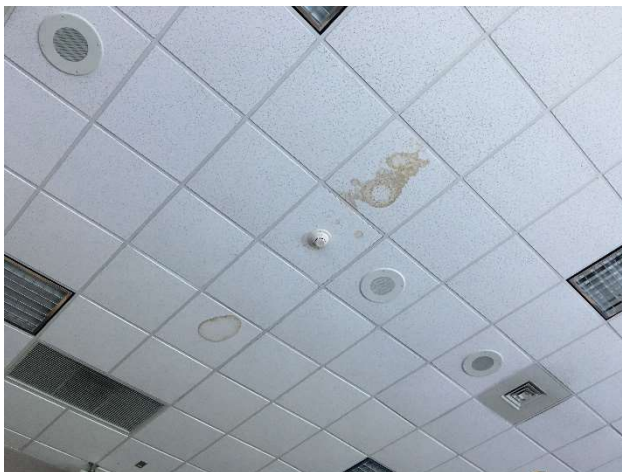
**Photo 15-05**  
Stained ceiling tiles at Business Class Club  
Suites

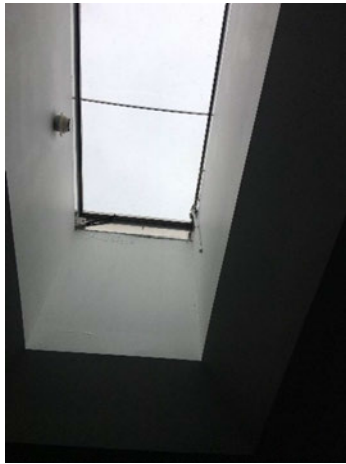
**Photo 15-07**  
Water damage at Goal Line Club Suite  
skylight

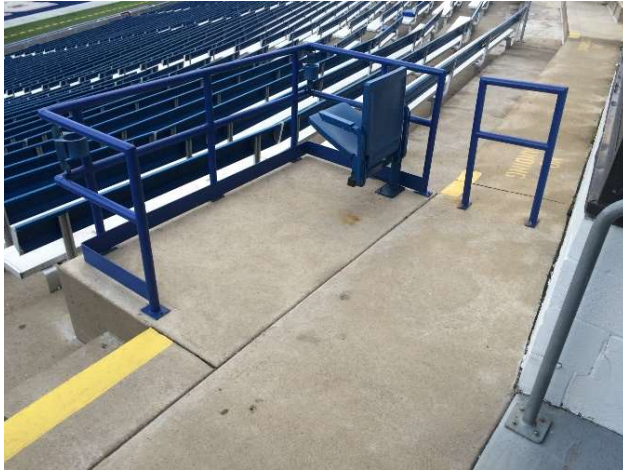
There are approximately 176 spaces available for wheelchair locations for viewing of the game. 66 of the seats are located at the end of vomitories. There is a dedicated wheelchair space with an adjacent companion chair as required per section 221.3 (Photo 16-01). In addition to the vomitory wheelchair spaces, platforms were constructed in sections 121, 122, 123 on the east side of the stadium and sections 101, 102 and 142 on the west side. These areas provide 108 spaces for wheelchair and companion seating.

**Photo 16-01**  
100 Level Wheelchair Seating with  
companion seat

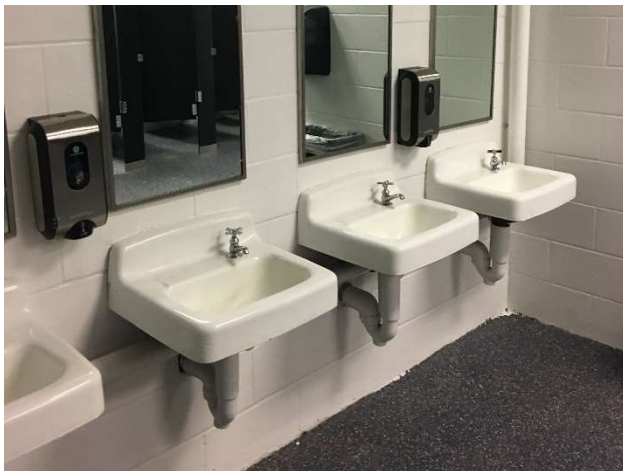
Almost all of the restrooms along the 100 level concourse had some degree of renovation to them during the 2014 capital improvements project. Everything that was newly installed, including the entry doors and accessible stalls meet ADA standards. In some bathrooms, some of the existing plumbing fixtures were not replaced and do not meet standards. Bathrooms 109.06, 114.07 and 131.06 do not have ADA compliant faucet handles (Photo 16-02) as required in section 309.4. Bathrooms 118.05,

**Photo 16-02**  
Restroom 131.06 sinks with non-compliant  
faucet handles

**Recommendations:** The deficiencies listed above are easily remedied and it is recommended they be upgraded during the next renovation project.

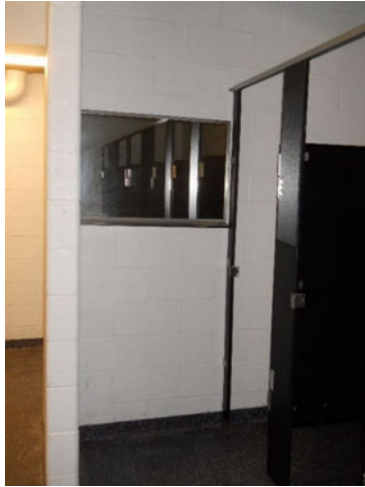
The only deficiency observed in the 8 berm bathrooms along the 100 level concourse was that the mirrors were mounted between 44 and 50 inches above the floor (Photo 16-04). These mirrors are located on the walls adjacent to the entrances and are not above a sink. Code section 603.3 requires that the bottom edge of the mirror be mounted 35" maximum above the floor when they are not located above lavatories or countertops.

**Photo 16-04**  
Berm bathroom mirror

**Recommendations:** It is recommended that the mirrors be removed and reinstalled to meet code.

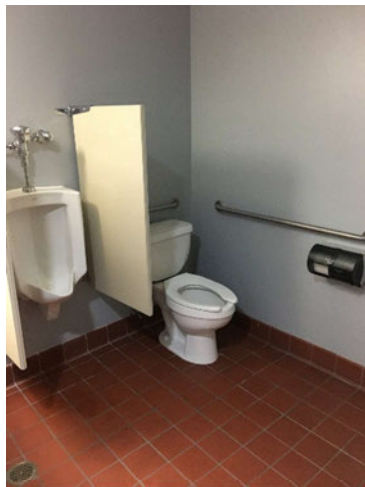
Additionally it was observed that almost all suites do not have coat hooks mounted at an accessible height, correct handicap grab bars and piping protection (Photo 16-05).

**Photo 16-05**  
Dugout suite restroom

**Recommendations:** It is recommended that pipe insulation be provided at all bathroom sinks and lower coat hooks where upper coat hooks are provided. When suite 103B is renovated a dedicated space for a wheelchair is recommended.

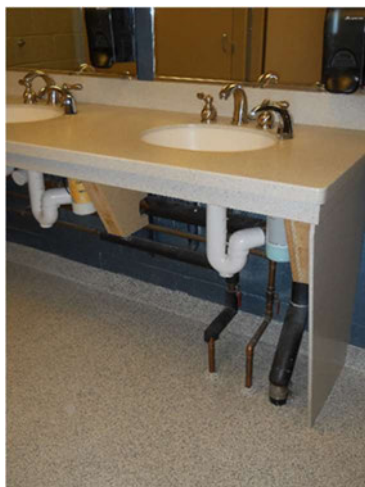
The restrooms meet accessibility standards. The only work that should take place is in the 203 and 242 men's room which has exposed supply piping under the counter (Photo 16-06).

**Photo 16-06**  
West End Suite restroom under counter  
piping

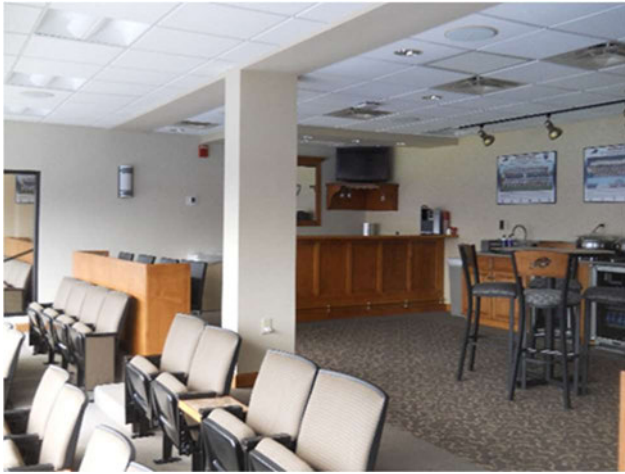
Of the 35 suites in this area, only suites 242 A & B, 243 B & D, 202 C and 203 D have a dedicated wheelchair space (Photo 16-07). The remaining 28 suites do not, instead they have tiered seating and a full height counter on the entry level floor (Photo 16-08).

**Photo 16-07**  
West End Suite 243B with wheelchair  
seating

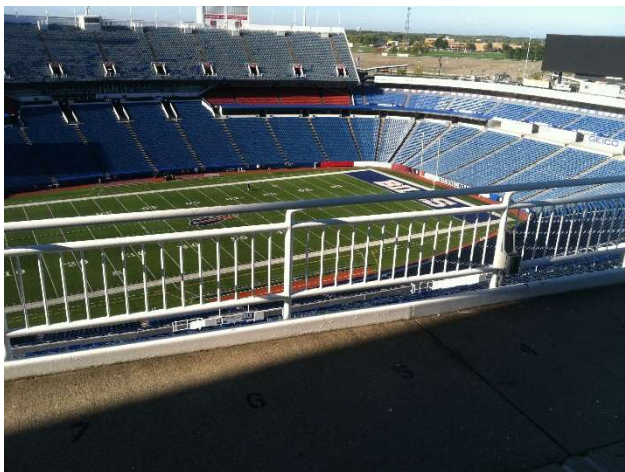
There is currently 60 spaces for wheelchairs available along the top row of the 300 level (Photo 16-09). Several of these seats have limited visibility due to the stairs from the upper walkway to the aisles (Photo 16-10). These spaces are accessible through the elevator located in the northwest restroom tower.

**Photo 16-09**  
Upper 300 level wheelchair spaces

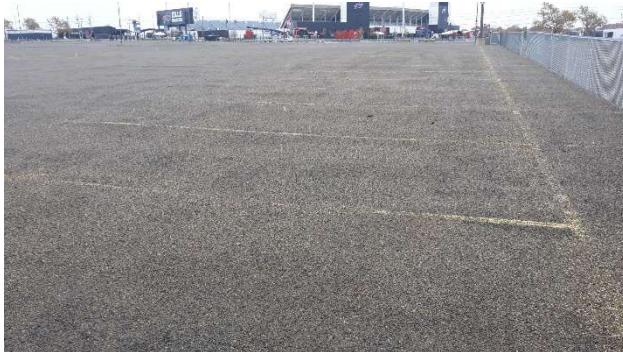
**Photo 18-05**

- A portion of Lot 3 was redone in 2018 and is in very good condition. A portion of this area has subsequently been surrounded by chain link fence and designated 'Tailgate Village' (photo 18-05).

2018 reconstruction at Lot 3.

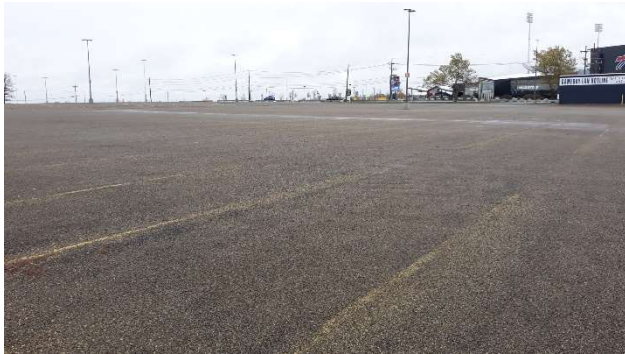
**Photo 18-07**

Intact shot and chip in southeast corner of Lot 4.

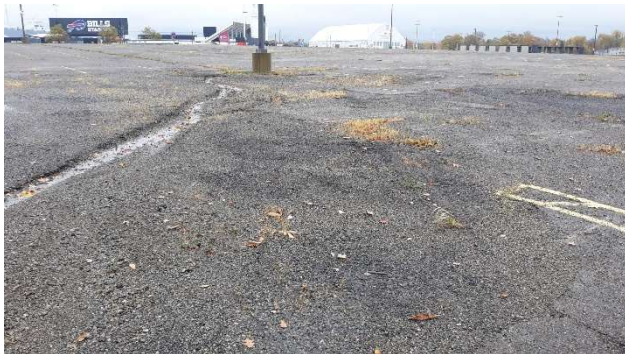
**Photo 18-08**

Extensive deterioration of shot and chip in Lot 4.

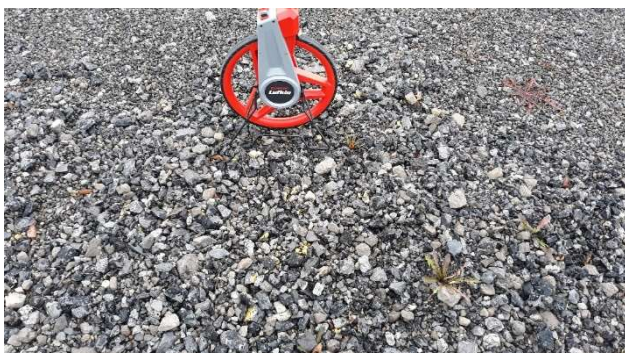
**Photo 18-09**

Subbase pumping up through failed shot and chip surface in Team Member Lot.

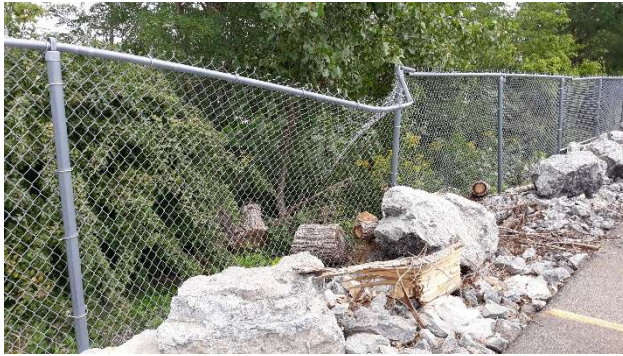
**Photo 18-16**

Included in quantities above is damaged top rail in Lot 7 North from a fallen tree limb. (Photo 18-16). Also, the 7'-6" blue fabric fencing along the top of bank on the east side of the training center storage

Damaged fence north side of Lot 7 North.

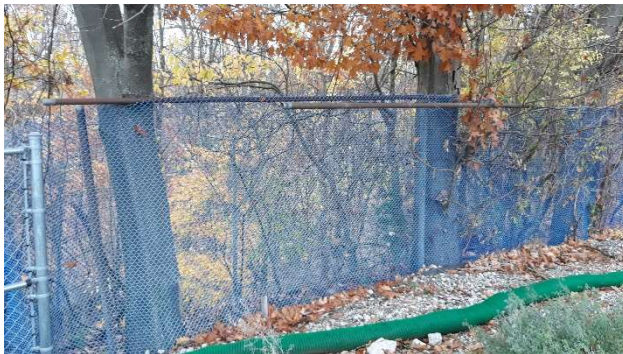
**Photo 18-17**

lot. (Photo 18-17). The top rail and post caps of the eight-foot-high galvanized chain-link fencing surrounding the Youth Football Stadium continue to corrode.

7'-6" fencing at top of bank on east side of training center storage lot.

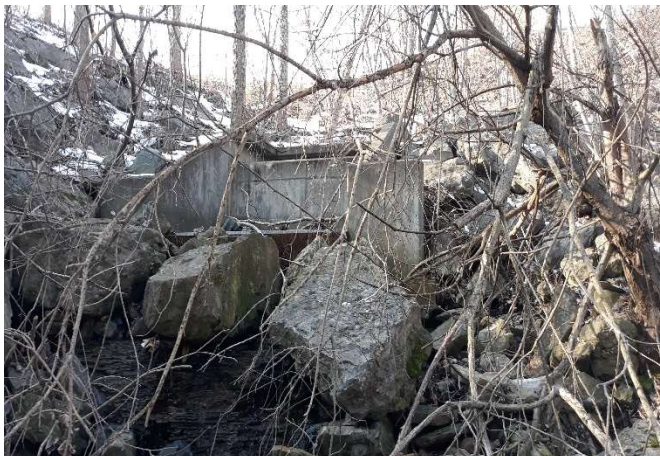
**Photo 18-21**

An energy dissipating structure was installed at the terminus of the 48" storm drainage trunk that follows Bills Drive, as part of the Training Center construction (1999). This structure appears to be generally functioning as intended, with only a small 1' deep erosion pool approximately 40' downstream of the structure (photo 18-21).

Vegetation growth at outlet to Smokes Creek located on east side of indoor practice field.

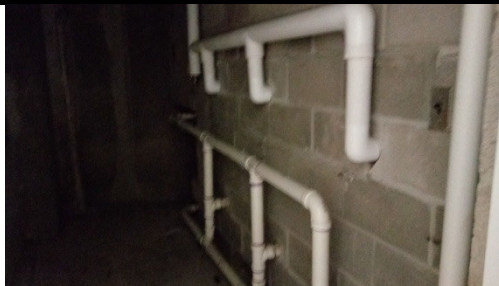
Image P3: Lavatories with exposed piping.

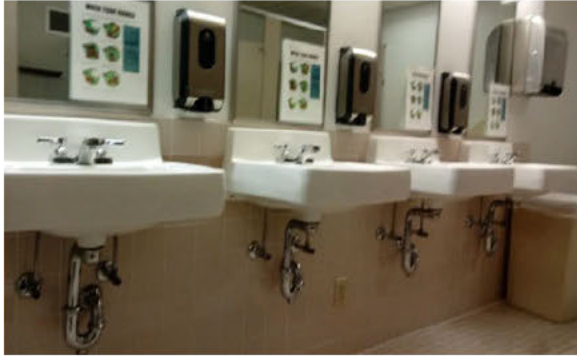
Image P9: Lavatories with piping exposed.

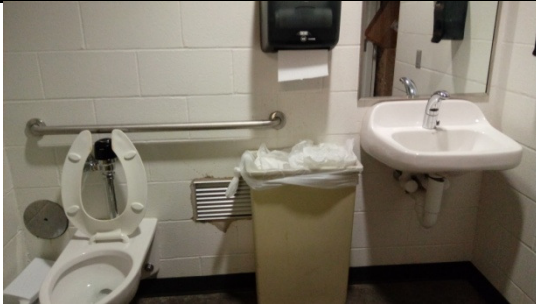
Image P31: Bathroom fixtures.

The fixtures are newer and of high-grade quality and well maintained and rated as very good condition. Life expectancy is 15 to 20 years. Traps and supplies are exposed and covered for wheelchair access. It was noted that at the time of the site visit, many of the fixtures had expired batteries requiring replacement and this result was no water in most urinal and water closet and lavatory traps causing odors to back up through the sewers into the toilet rooms. Facilities was going to address the issue.

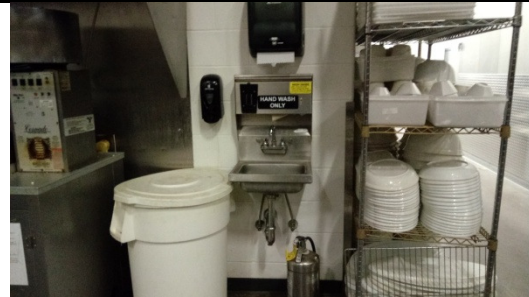
Image P32: Kitchen fixtures.

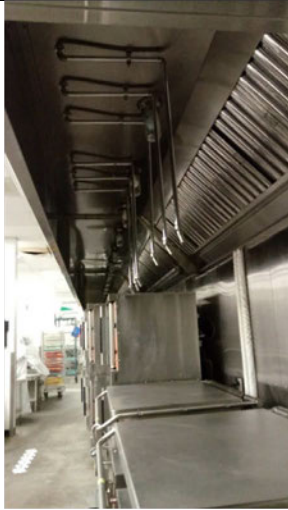
Image P40: Kitchen hood and cooking equipment.

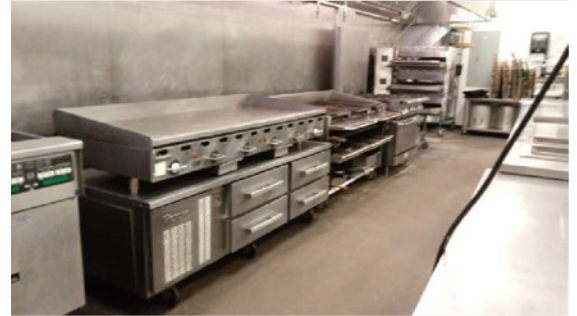
Image P41: Kitchen cooking equipment.

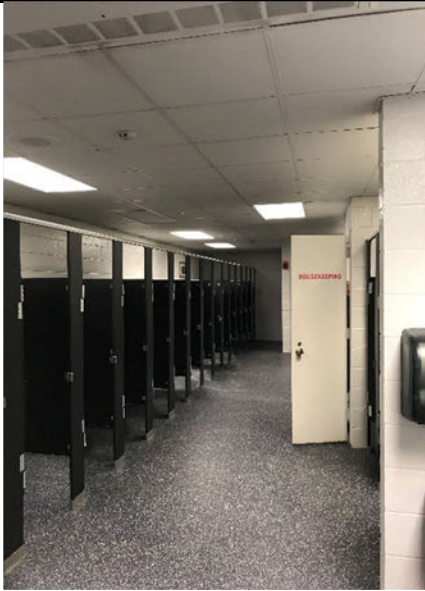
300 Level Concourse Toilet Rooms: These restrooms were renovated in 2014 under the 2014 Stadium Improvement Project. They consist of 2x4 (4) lamp T8 recessed fluorescent fixtures, occupancy sensors, and general receptacles. (Image E1)

Image E1 Typical 100 and 300 Level Toilet Room

The convenience receptacles in the toilet rooms appear to be operational and in good condition. The existing lighting, lighting controls, and receptacles are generally in good working condition with the exception of general cleaning/maintenance. The typical life expectancy for a fluorescent fixture is approx. 20-25 years. The typical life expectancy of an occupancy sensor is approx. 10-15 years.

At this time, it is recommended to perform general cleaning of dirt/debris from fixtures, replace any damaged/yellowed acrylic lenses, and replace any T8 lamps or ballasts as required. The 100 and 300 Level Concourse toilet room fixtures still have many years of expected life remaining.

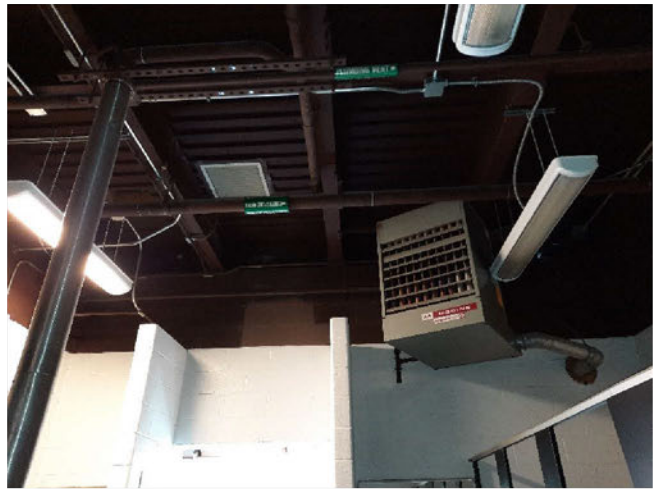
Image E2 Typical Berm Toilet Room

The Tower, 200 Level, and Berm Toilet Rooms are nearing or at the end of their expected life cycle of approximately 20-25 years, but are still in good working condition. Replacement of these fixtures should be considered during the next major renovation of these toilet rooms.

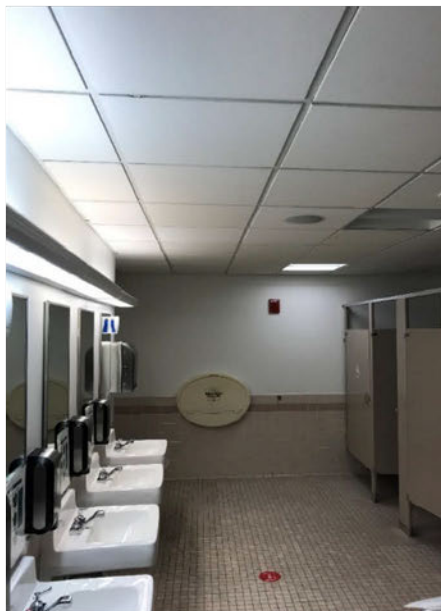
Image E3 Typical 200 Level Toilet Room

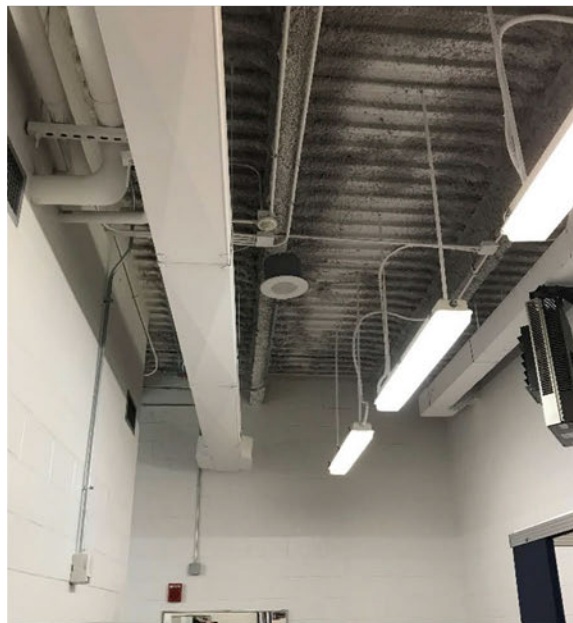
Tower Toilet Rooms: These upper-level tower restrooms were constructed in the 1999 Project, and the mid-level tower restrooms were constructed in the 2002 project. The electrical systems consist of 4' pendant mounted wet location T8 fluorescent fixtures, keyed light switches, and general receptacles. (Image E4)

Image E4 Typical Tower Toilet Room

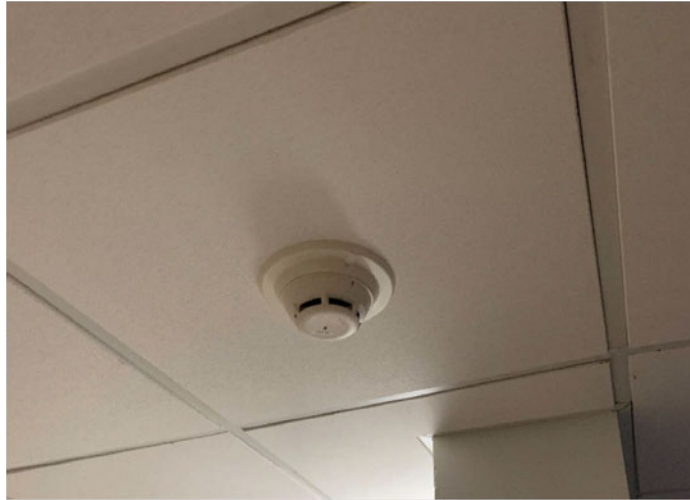
Image E16 Typical Restroom Smoke Detector

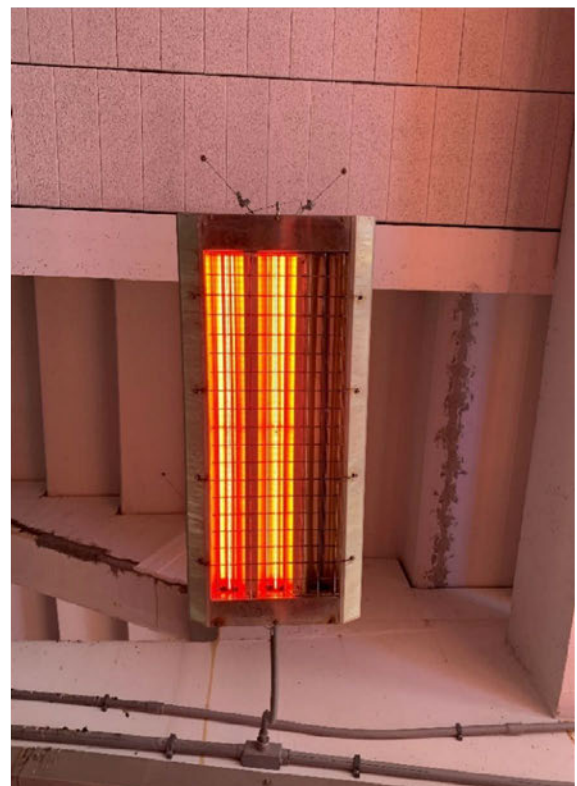
Image E21 Typical IR Heater with Element Out

The IR heaters are generally in good working condition, but are exposed to the elements and subject to adverse weather conditions/wind. There is a stock of spare fixture housings and parts in the club level basement, which is being used to replace/repair any damaged heaters as needed. The life expectancy of an IR heater is approximately 15-20 years. The existing IR heater is still being manufactured and replacement parts are still readily available from the manufacturer.

The IR heaters are still within their useful life expectancy and are generally in good working condition. It is recommended to repair any broken hangers/supports, repair any damaged PVC conduits, and replace the heating elements as required.

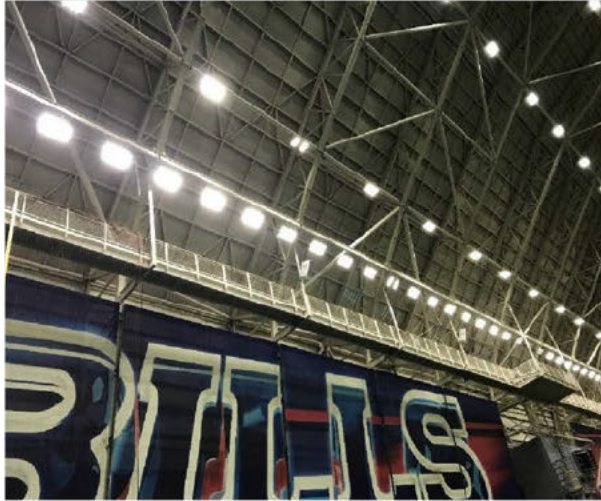
Image E33 Field House Lighting

The manufacturer's listed life cycle for the field house LED fixtures is 50,000 operating hours (L85 = 85% of initial lumen output). In general, the fixtures were in good working condition. Some of the fixtures were either fully out or partially out, which can likely be attributed to faulty drivers or dimming cards. Replacement LED drivers are still manufactured for these fixtures, but the dimming cards are no longer manufactured and aren't available for purchase. The manufacturer does offer a solution for the existing dimming cards to be repaired.

It is recommended to continue to maintain the existing LED field lighting fixtures, and continue to replace any fixtures/components that are not fully functional.
